**Stauf SMP-960 Glue**

**In-Situ Impact Sound Insulation Test Report**

Document No.  
30U-12-0052-TRP-302053-0

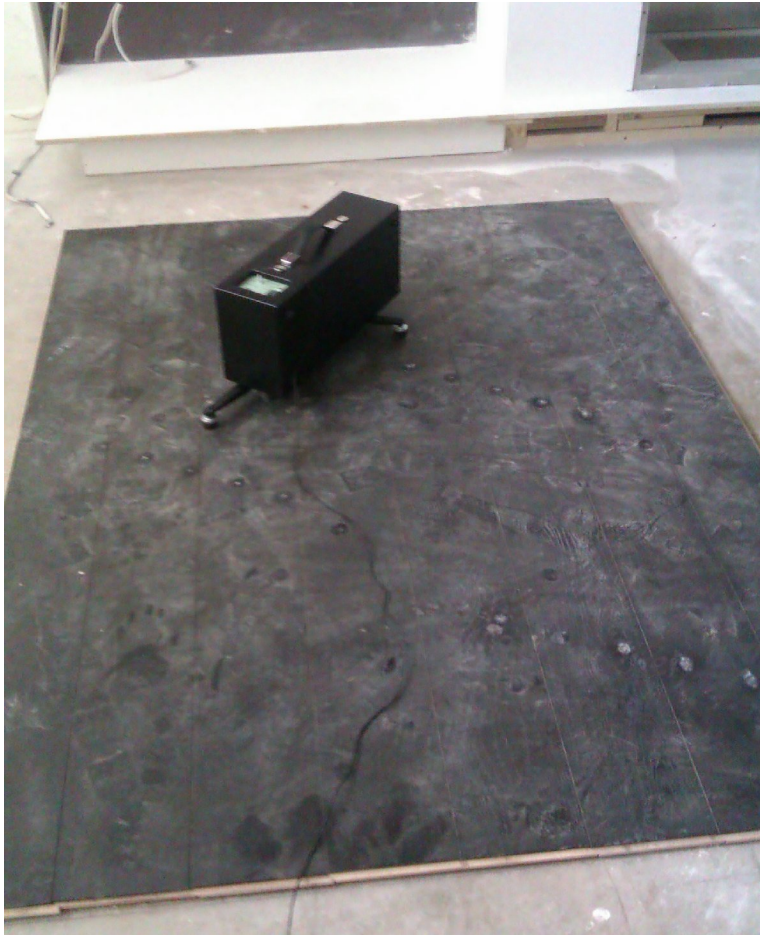
Measurements of the Impact Sound Insulation was conducted in accordance to the procedures of AS ISO 140.7. A standard tapping machine was placed at four different locations on the timber flooring area in the source room (unit 1902) at an angle of 45° with the floor board joints. (See **Figure 1**).

**Figure 1:** Tapping machine in-situ

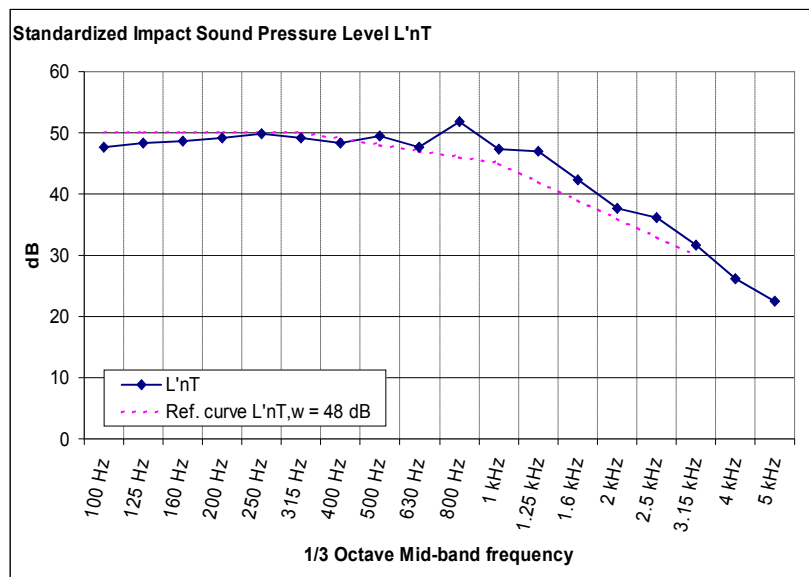
**Table 2 & Figure 2: Measurement results**

The measured Standardized Impact Sound Pressure Level for the configuration tested between unit 1902 and 1802 at 15 Collins Street, Melbourne, on 5 September 2012 is summarised in **Table 2** and presented graphically in **Figure 2**.

- 21mm oak flooring adhere using 4mm thick Stauf SMP-960 glue (approx. 4mm thick) installed on
- a concrete slab [thickness reported by Stauf: 200mm] with 5mm screed
- Ceiling below: 16mm thick compressed fibre ceiling tiles suspended 130mm from the slab by an aluminium frame)

1/3 octave mid-band frequency	Standardized Impact Sound Pressure Level L'nT (dB)
100 Hz	47.7
125 Hz	48.3
160 Hz	48.7
200 Hz	49.1
250 Hz	49.8
315 Hz	49.1
400 Hz	48.3
500 Hz	49.5
630 Hz	47.7
800 Hz	51.8
1 kHz	47.3
1.25 kHz	47
1.6 kHz	42.4
2 kHz	37.7
2.5 kHz	36.1
3.15 kHz	31.7
4 kHz	26.1
5 kHz	22.5
<b>Single number value</b>	
$L'_{nT,w} = 48 \text{ dB}$	
$C_1 = -3 \text{ dB}$	
<b><math>L'_{nT,w} + C_1 = 45 \text{ dB}</math></b>
