# TECHNICAL PUBLICATION

## VENTILATION UNDER TIMBER FLOORS

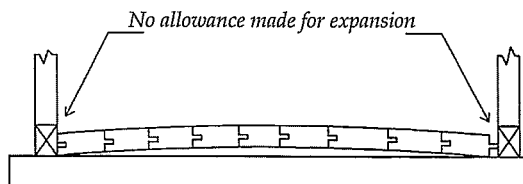
Figure 3. Doming or blown floor.

Alternatively, the floor may react to excess moisture by lifting in a continuous curve, known as doming either pulling the nails from the joists or lifting the entire floor framing off its supports. Excessive springiness of the floor, particularly towards the centre of the room is usually a fair indication of this problem. Doming may occur during periods of excessively wet weather but, providing the nails have not pulled, when the weather conditions revert to normal or the underfloor conditions are corrected, the floor will usually return to normal.

A blown floor on the other hand may be severe enough to actually force two or more boards up to form a peak or sawtooth effect. This is normally the result of insufficient expansion joints being provided in a large floor area and will often be more severe where a secret nail T&G profile

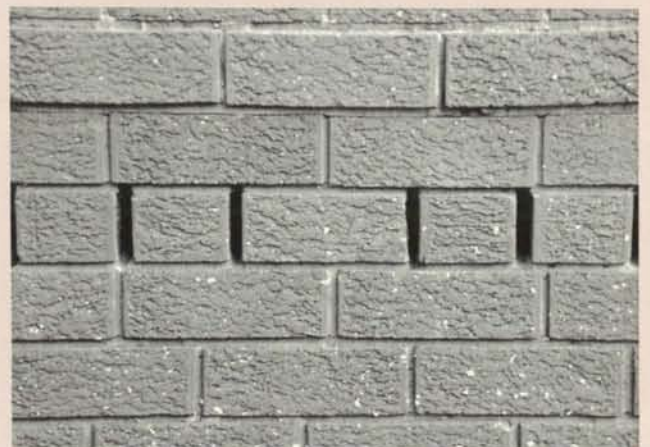
*Figure 5. Spaced brick ventilation.*

The minimum suggested requirement for 2100 mm<sup>2</sup> of ventilator space per lineal metre of external wall is approximately equivalent to a row of unmortared brick joints of normal size all the way around the house. This, while being an unobtrusive way of providing the minimum requirement, means the gaps will only be some 7-10 mm in width. If, as is usually the case, maintenance of ventilator space is neglected, the likelihood of blockages from the original mortar, spiders' webs or other foreign material will soon render the available ventilation useless. More common these days is for the aggregation of the necessary gaps into groups of three or four, 50 mm wide spaces in the bricks. While that usually makes for easier bricklaying, another and better way of ensuring good cross ventilation is to provide a continuous row of open mortar joints of around 20-25 mm.

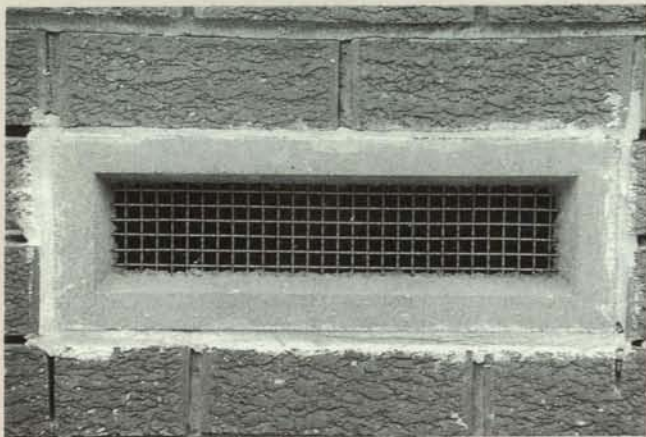
Figure 6. Bronze mesh ventilator.

Where the foundation wall is easily accessible, the installation of additional vents in the form of cement framed bronze mesh ventilators offer a practical alternative. Available in various sizes, they are made to suit standard brick patterns and provide clear space of

up to 25,900 mm<sup>2</sup>. Where it is not practicable to provide additional natural ventilation, the installation of mechanical ventilators may solve the problem. These units are usually vented above the roof and generally work on the same principle as the wind driven roof space ventilators that are becoming increasingly popular. Because of site variations and the often substantial differences in performance of these mechanical units it is impossible to make any recommendations regarding brands, types or quantities required. The best advice would be to consult the various manufacturers or to engage a specialist in the field.
