Nash Timbers Site Inspection Process

NASH TIMBERS SITE INSPECTION PROBLEMS IDENTIFIED & ADDRESSED IN A Renovation and addition to an existing home

Scenario 1: DOWNSTAIRS EXISTING FLOOR

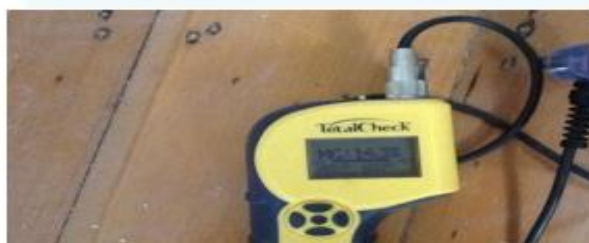
Moisture meter- Sub Floor testing at 14.3% (unable to install as MC variation is 3.2%)

ISSUES IDENTIFIED	WAYS TO ADDRESS
Moisture sub floor (damp soil, black around nails, musty smell)	Reduce MC In floor board Cross Ventilation, mechanical or vents
Existing floor MC =14.3%	Apply moisture barrier glue
Existing floor has lacquer finish-	Cross Sand
Existing floor unlevel	Cross sand Installation 1. Control joints as per EMC 2. Glue application 3. Nailing techniques

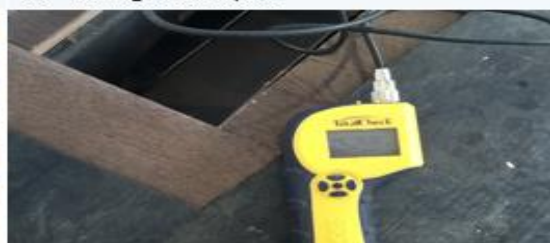
Moisture meter- Floor Board testing at 11.1% (only 2% variation is acceptable between sub floor and floor board)

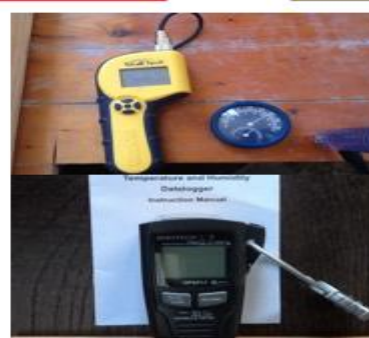
Nash Timbers completed a Site Checklist and performed the EMC calculation the result showed that each Roasted P-board will grow 1mm. On this information it was decided that 1mm packers would be put between each board. The packers are pulled out in 24 hours, already after 10 days the control joints have reduced 0.5mm. The 2nd photo shows the 1.5mm control joints after the packers are pulled out.

1MM CONTROL JOINTS AFTER SPACES PULLED OUT

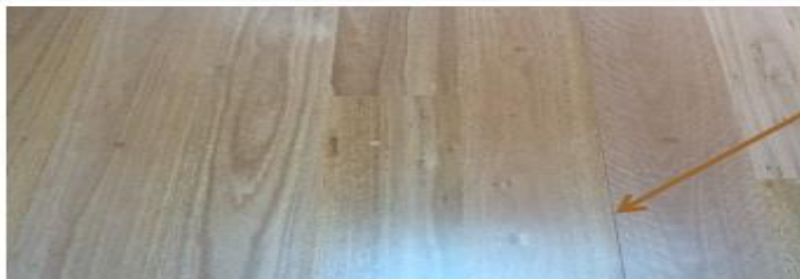
Control joints allow for the timber to take in moisture. Depending on the site how many control joints will be installed

ISSUES IDENTIFIED	WAYS TO ADDRESS
Concrete slab <u>uneven</u>	1. Ardit to level (then install ply) 2. Spike & level battens
Concrete slab moisture content above 75%	1. Apply moisture barrier 2. Lay plastic film
	Installation: 1. Control joints as per EMC 2. Glue application 3. Nailing techniques

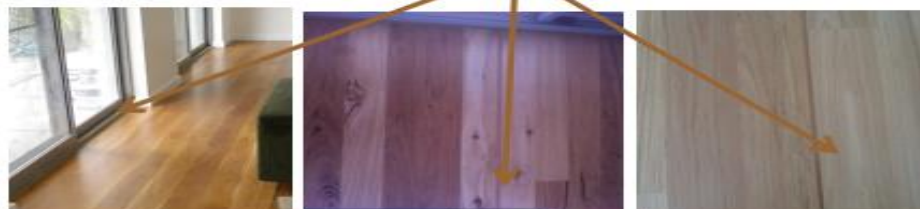
Corking

Cork is installed between 4 to 6 metres depending on the width of the board and also around the borders of the room where there is no skirting board
